Colonial Revival

Italianate

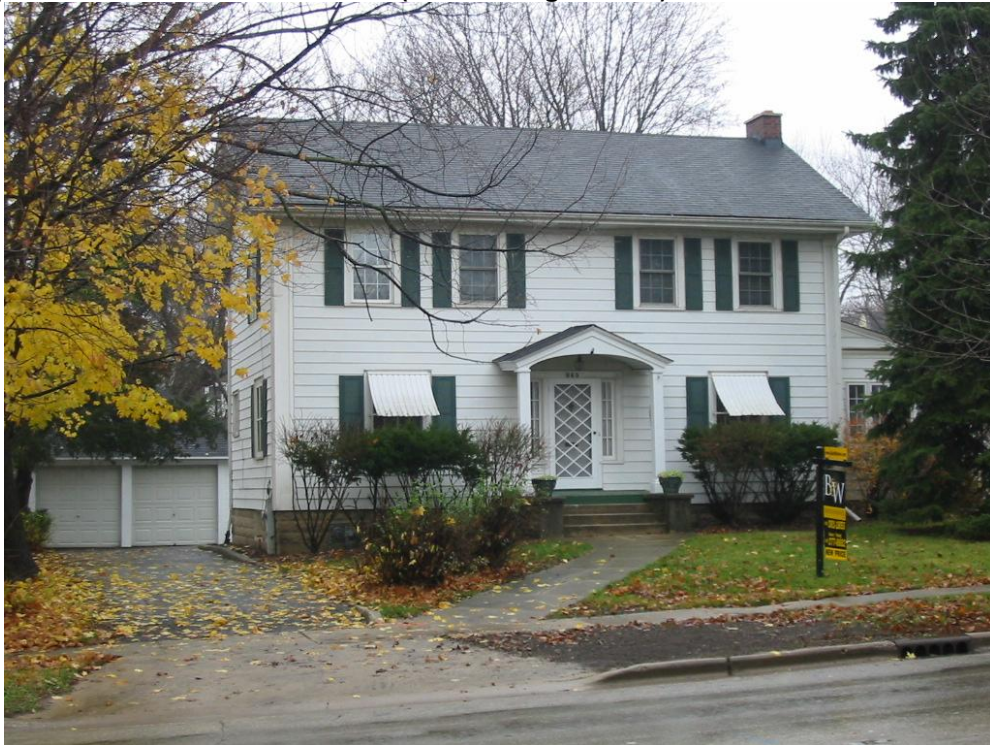
Example of a Colonial Revival House (645 S. Hough Street)

This simple interpretation has square columns supporting the entry. The wide corner trim boards are likewise a simple interpretation of the pilasters common to this style. The gentle arch on the underside of the gable roof of the entry is typical of Colonial Revival.

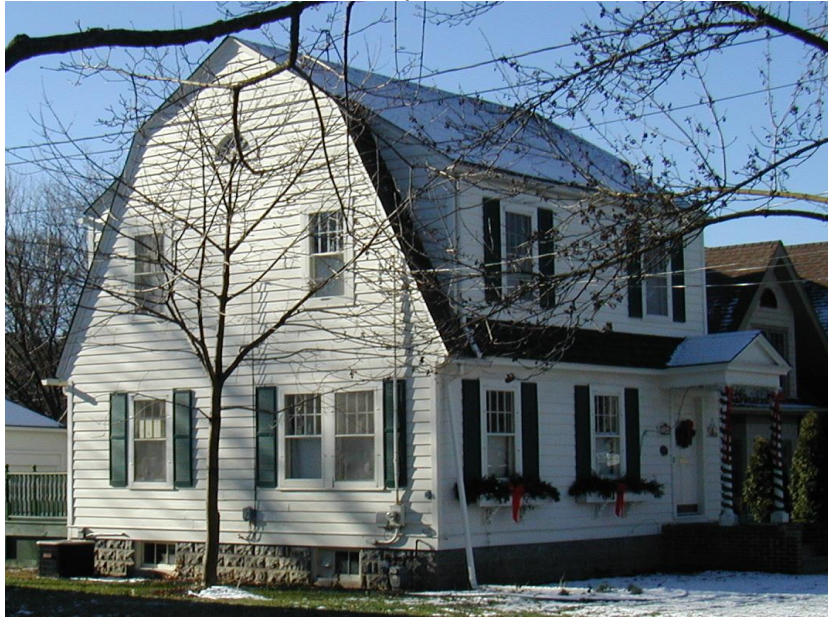
Example of a Dutch Colonial Revival House (239 W. Russell Street)

This Sears and Roebuck “Honor Bilt” house shows the gambrel roof and shed dormers that are typical of the style. The windows are original eight-over-one double hung. The pedimented entry porch is traditional for this Colonial Revival homes.

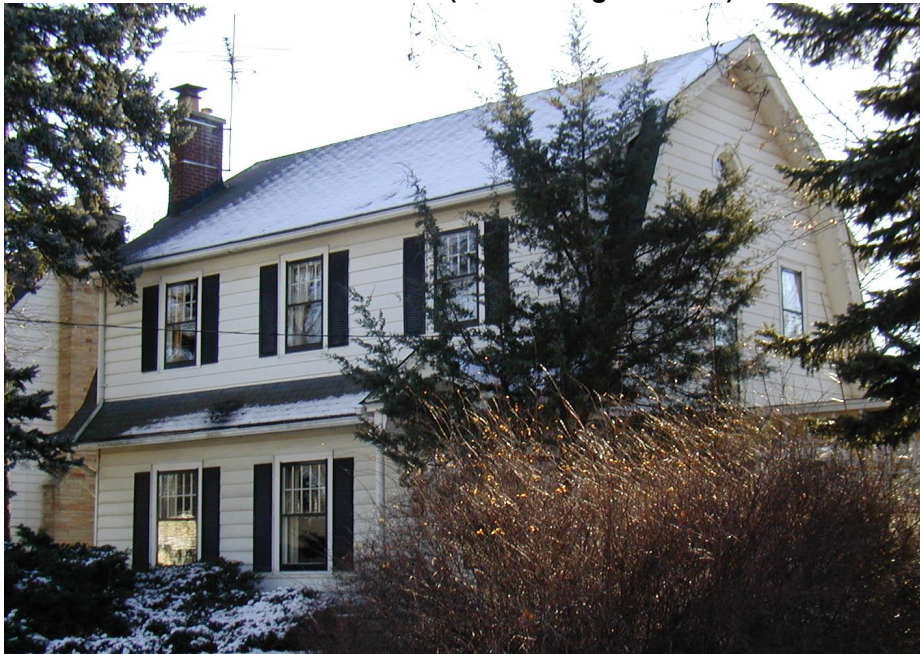
Example of a Dutch Colonial Revival House (129 Coolidge Avenue)

The gambrel roof shows the Dutch Colonial influence. The entry porch (partly obscured by the tree in the photograph) is arched, beneath a front-facing gable, and the original six-panel wood door is intact. The windows are ten-over-one and eight-over-one double hung.

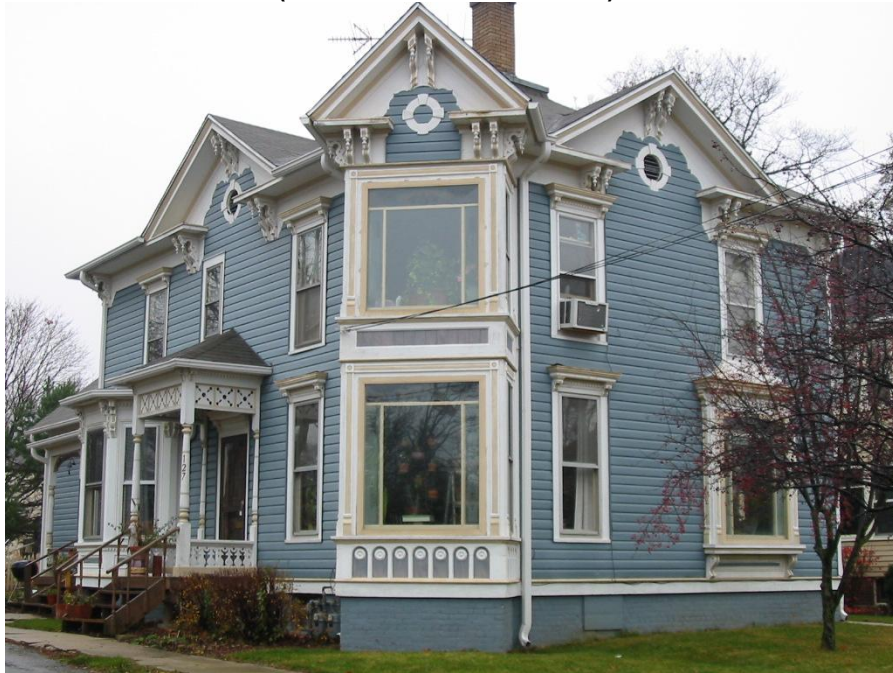
Example of an Italianate House (127 West Lincoln Avenue)

This house is distinguished by its highly ornamental paired eave brackets that are the hallmark of Italianate influence. The elaborate trimwork above the windows is also characteristic of the style.
